Town of Chapel Hill Lower Booker Creek Subwatershed Study

Volume I : Report

September 2018

Prepared by
W. K. Dickson & Co., Inc.
Raleigh, NC
919/782/0495
NC License No. F-0374

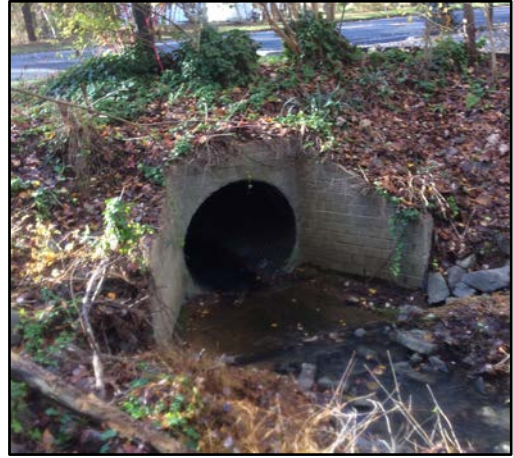
Picture 4-2: Honeysuckle Road – Existing CMP

Residents upstream of Honeysuckle Road would have between 0.4 and 1.0 foot reductions in the 25-year storm and between 0.35 and 0.45 foot reductions in the 100-year storm.

The existing culvert at Honeysuckle Road overtops during the 10-year event and can back water into the properties at 2411 and 2415 Honeysuckle Road causing significant property damage. Replacing the existing culvert with an 8' by 4' reinforced concrete box culvert (RCBC) would provide a 25-year level of service based on built-out conditions assuming the Red Bud Storage Area is constructed as well. If the Red Bud Storage Area is not implemented, then an 11' by 4' RCBC would be required to provide a similar level of service.

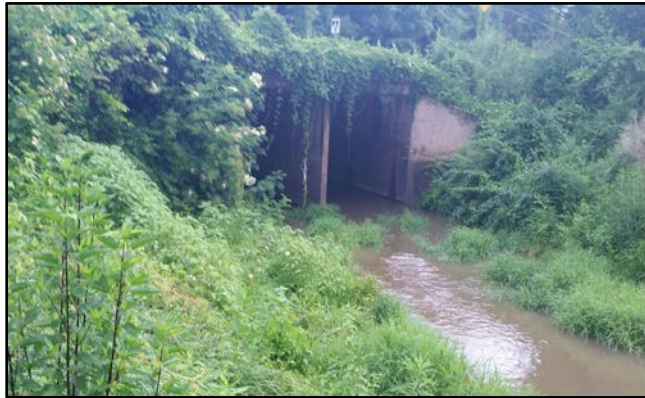
Picture 4-4: East Franklin Street – Existing RCBCs

With the improvements proposed downstream (See Figure 4-9) including the proposed storage area adjacent to the Eastgate Shopping Center upstream of South Elliott Road, the water surface elevations will be lowered along this segment of Booker Creek. At East Franklin Street, water surface elevations will be reduced by 1.5 feet during the 25-year storm event

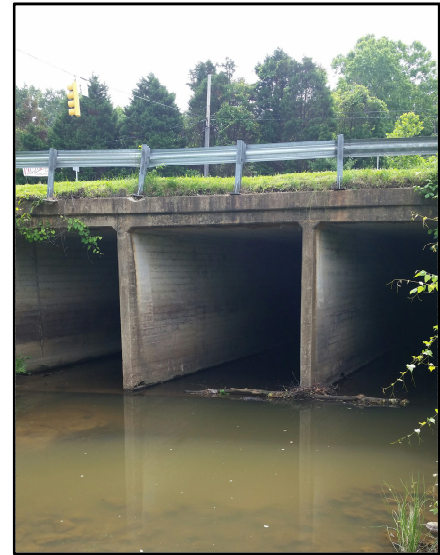
Picture 4-5: Highway 15-501/Fordham Boulevard – Existing RCBCs

The proposed downstream improvements (See Willow Drive below) will reduce the water surface elevations at Highway 15-501/Fordham Boulevard by 0.8 feet in the 25-year storm event and 0.5 feet in the 100-year storm event. With these lower water surface elevations, this crossing will continue to pass the 100-year storm event with additional freeboard. The existing culverts are in good condition; therefore, no improvements are proposed for this location.

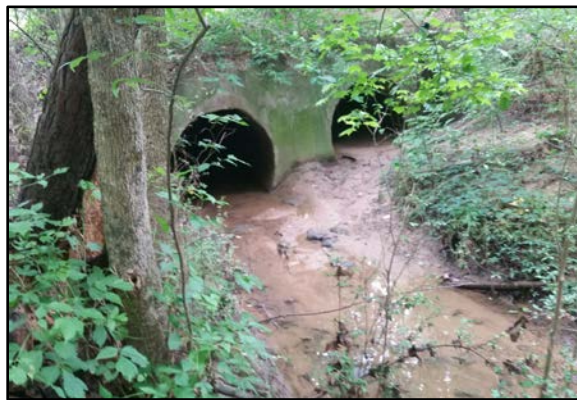
Picture 4-6: Summerfield Crossing – Existing RCPs

Summerfield Crossing – The existing twin 66" RCPs at Summerfield Crossing meet the desired 10-year level of service. The culvert is in good condition (See Picture 4-6) and passes the future 100-year flows with almost one foot of freeboard. Consequently, no improvements are proposed at this location.

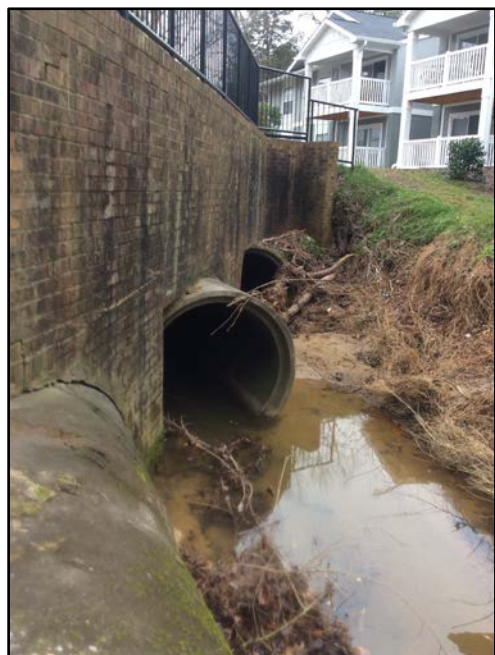
Picture 4-7: Foxcroft Drive – Existing RCPs

reduced by 1.4 feet in the 25-year storm event at Foxcroft Drive.

The existing culvert crossing meets the desired level of service however water backs up behind the Foxcroft Drive culverts and could potentially cause flooding of property at the Foxcroft Apartments. The proposed 12' x 4' RCBC would reduce water surface elevations by 1.4 feet upstream of Foxcroft Drive during the 25-year storm. Prior to implementing this project, the Town should survey finished floor elevations and lowest adjacent grade elevations at the apartments to better quantify the benefits of the culvert upgrade.

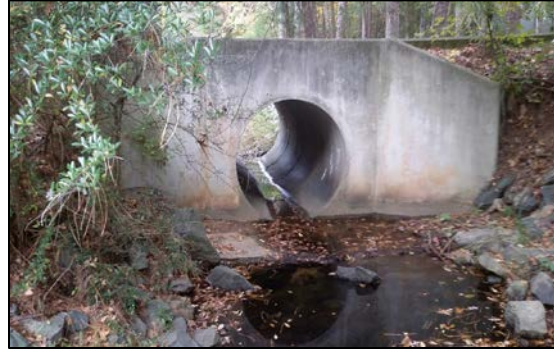
Picture 6-3: Booker 1 looking upstream– Perched Culvert

Booker 1 has a large scour pool at the upstream end, where the culvert discharges the creek under Honeysuckle Road. The banks in this scour pool area are eroding, and potentially threatening Honeysuckle Road. Farther downstream, there are areas where the steep stream banks are relatively stable, and others where they are not. Additionally, there are multiple driveway crossings of the creek that have perched culverts, which are evidence of channel scouring and incision, where grade control has been lost. These perched culverts also degrade aquatic habitat. The creek flows beside the road for most of this reach, so access is very good. The 8" sewer line that parallels the road does not present apparent obstacles to the project, however the road and private property along the reach limit buffer enhancement to an extent.

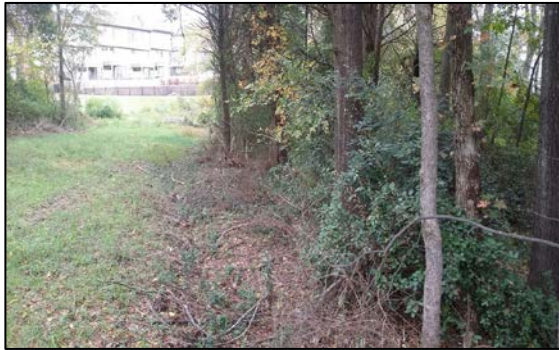
Picture 6-6: Dobbins 3 looking upstream – RSC
Opportunity

Dobbins 3 is located just downstream from an existing dry pond SCM south of Turvey Court in an apartment complex. The channel here is incised, with eroding banks, and is a candidate site for either natural channel restoration or RSC implementation. There is existing buffer on both sides of the stream, but enhancement may be possible. Duke Energy owns the property where this site is located, and accessibility to the channel is good. There are limited sanitary constraints for this reach with the exception being the upstream portion near the dry pond.

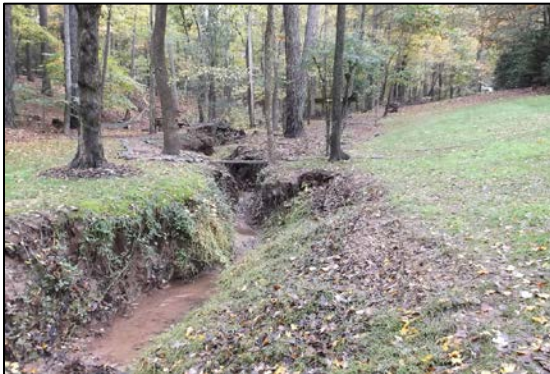
Picture 6-8: Oxford 2 looking downstream – Stream
Stabilization/Buffer Planting

Oxford 2 is located south of Red Cedar Place. There is an existing head-cut that has created channel incision and eroding stream banks in the back yard of a private residence. Potential stabilization activities include repairing the head-cut and establishing channel grade control, repairing eroding stream banks, and buffer enhancement. There is an 8" sewer line nearby, but it is not visible, and does not appear to impair stabilization activities. Access to the channel is good.

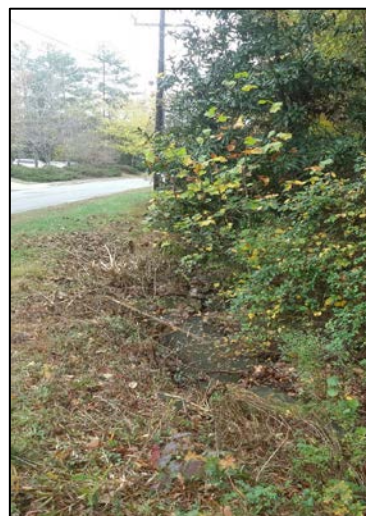
Picture 6-9: Velma 2 looking downstream – RSC Opportunity

Velma 2 is located parallel to North Elliott Road, the upstream end begins at Velma Road, and the downstream end is a culvert under East Franklin Street at a fire station. There is a head-cut that has created steep, eroding banks. This site is a candidate for channel stabilization including repair of the head-cut and establishment of channel grade control, repair of the eroding banks, and buffer enhancement. An RSC design is possible here also. There is an 8" sewer line along the left bank and North Elliott Road, but its alignment does not appear to be a constraint on stabilization activities. This reach is located on private property and access to the channel is fair.
